The
LaQUE CENTER
FOR CORROSION TECHNOLOGY, INC.

**SEAWATER CREVICE CORROSION RESISTANCE OF
STAINLESS STEELS COATED WITH
SILANE AND ANTIFOULING PAINT SYSTEMS**

**FINAL REPORT
CONTRACT N00014-01-C-0177**

August 2002

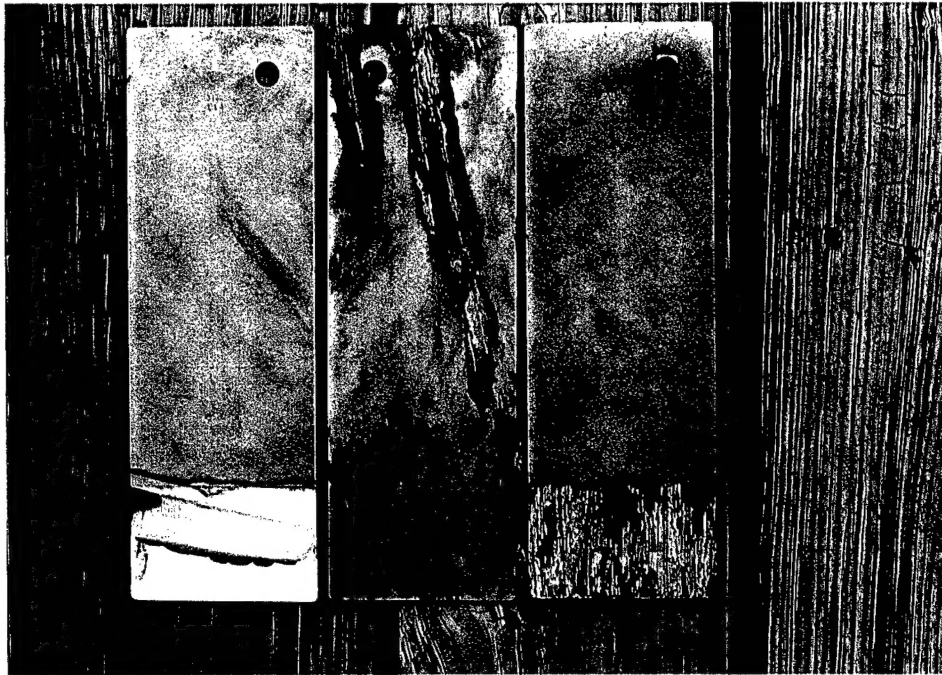
Figure ES-1. Comparative views of S31603 specimens partially coated with (left-right) epoxy, silane alone and silane + ablative-Cu and exposed for nine months.

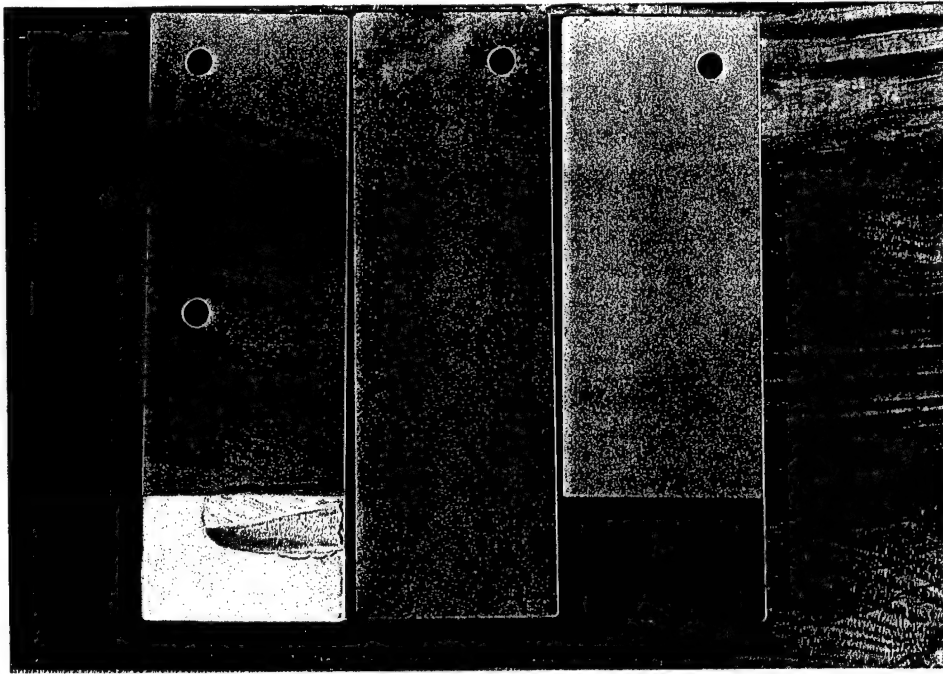
FIGURE 3 – Representative view (left) affected epoxy coated and (center and right) resistant silane and silane + ablative Cu coated N08367 specimens after three months seawater exposure.

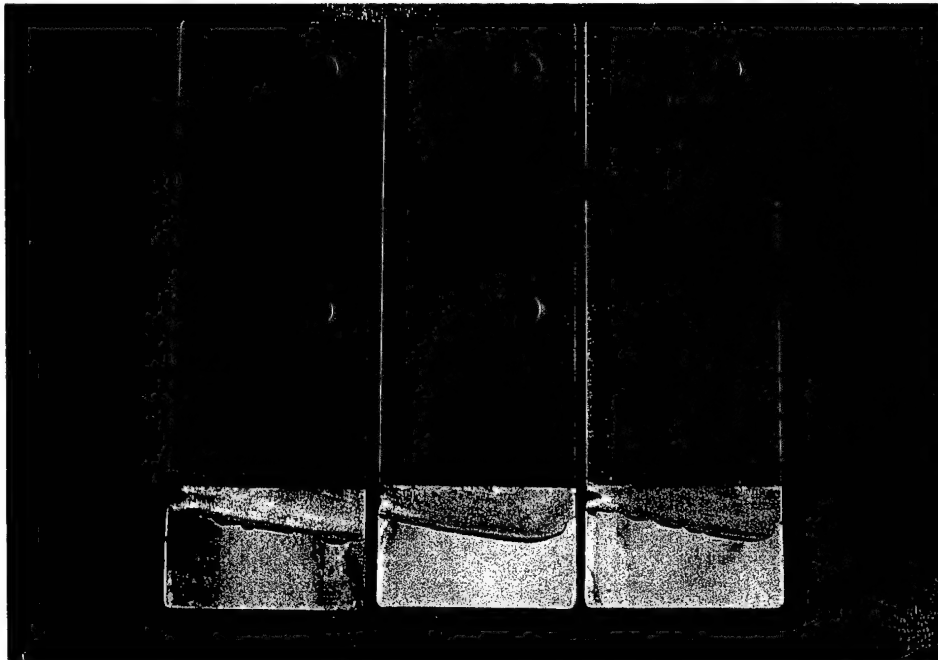
FIGURE 4 – View of partially cleaned S31603 specimens with 20% epoxy coverage showing extensive crevice corrosion and pitting.

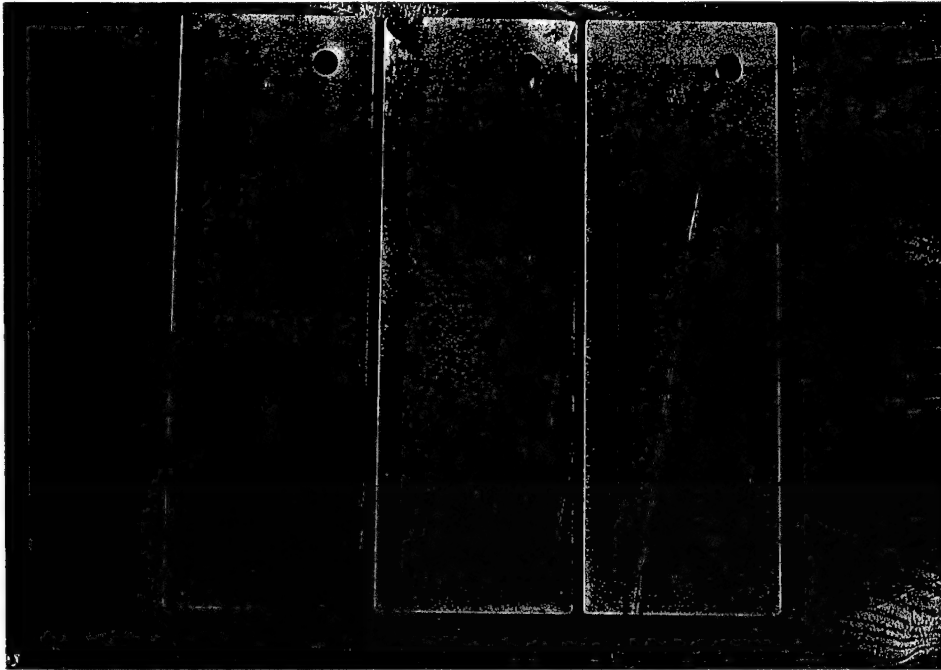
FIGURE 5 – View of partially cleaned S31603 specimens with 80% silane coverage (left to right: Silane A, B and C).

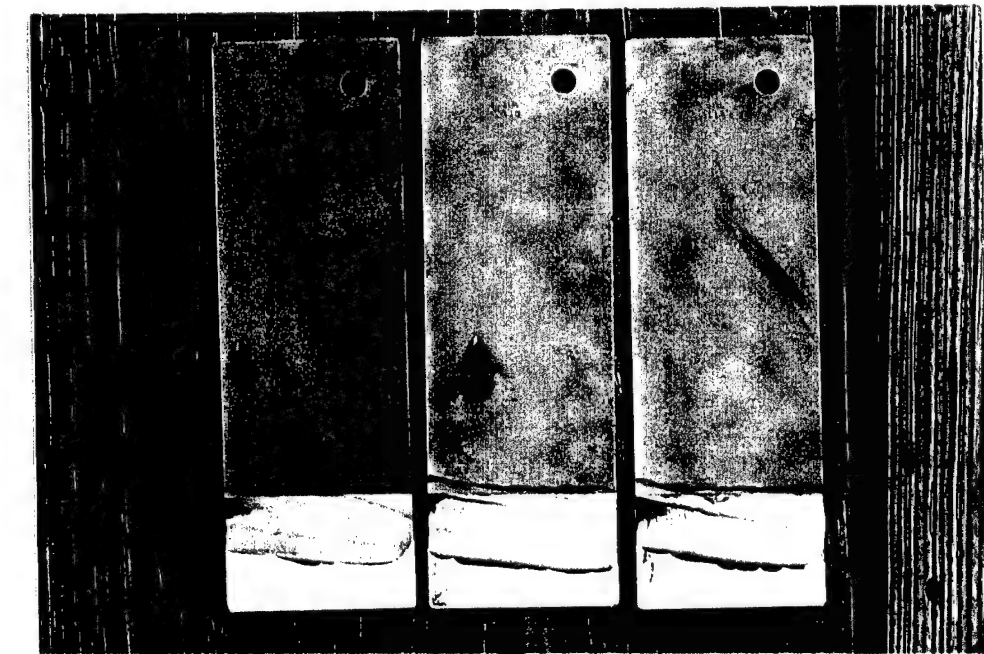
Figure 18.1 2609-04-019-1A

Figures 18.1 and 18.2 (20%), and Figures 19.1 and 19.2 (80%) show the extent of crevice corrosion which developed beneath the epoxy coating on S31603 specimens in nine months. Figures 18.3 and 19.3, respectively, compare the "worst case" condition of the preceding with that found on corresponding specimens removed after only three months.

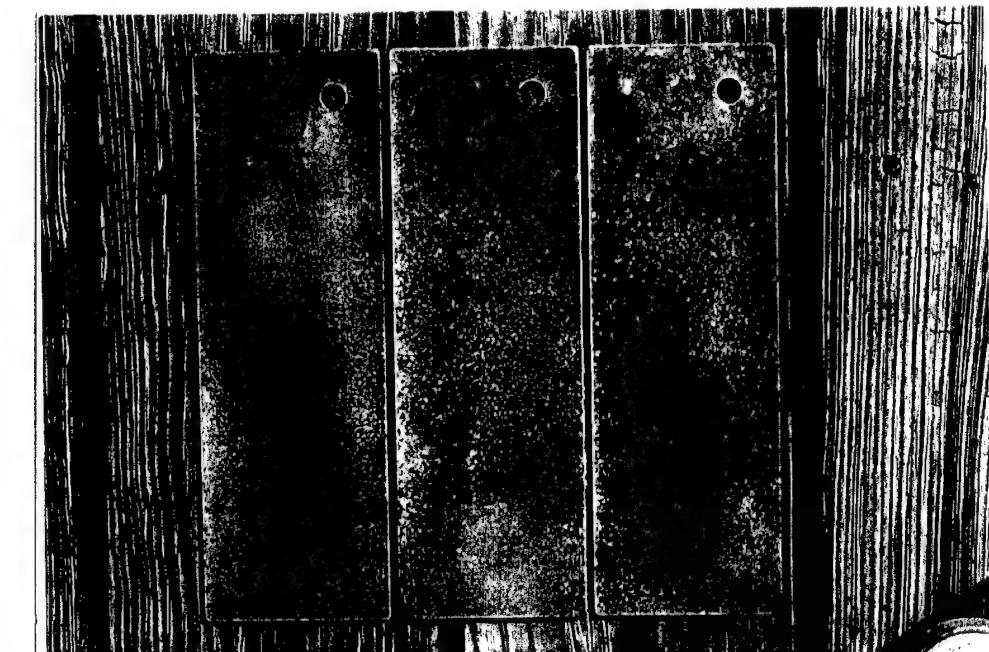
Figure 24.1 2609-04-020-19

In contrast to the above, final inspection of the 18 partially coated N087367 specimens (Figures 24.1 to 25.3) revealed no evidence of corrosion within the areas coated (20% and 80%)
